First Christian Church
553 Fallowfield Avenue
Charleroi
Washington County
Pennsylvania

HABS No. PA-5358

HISTORIC AMERICAN BUILDINGS SURVEY

FIRST CHRISTIAN CHURCH

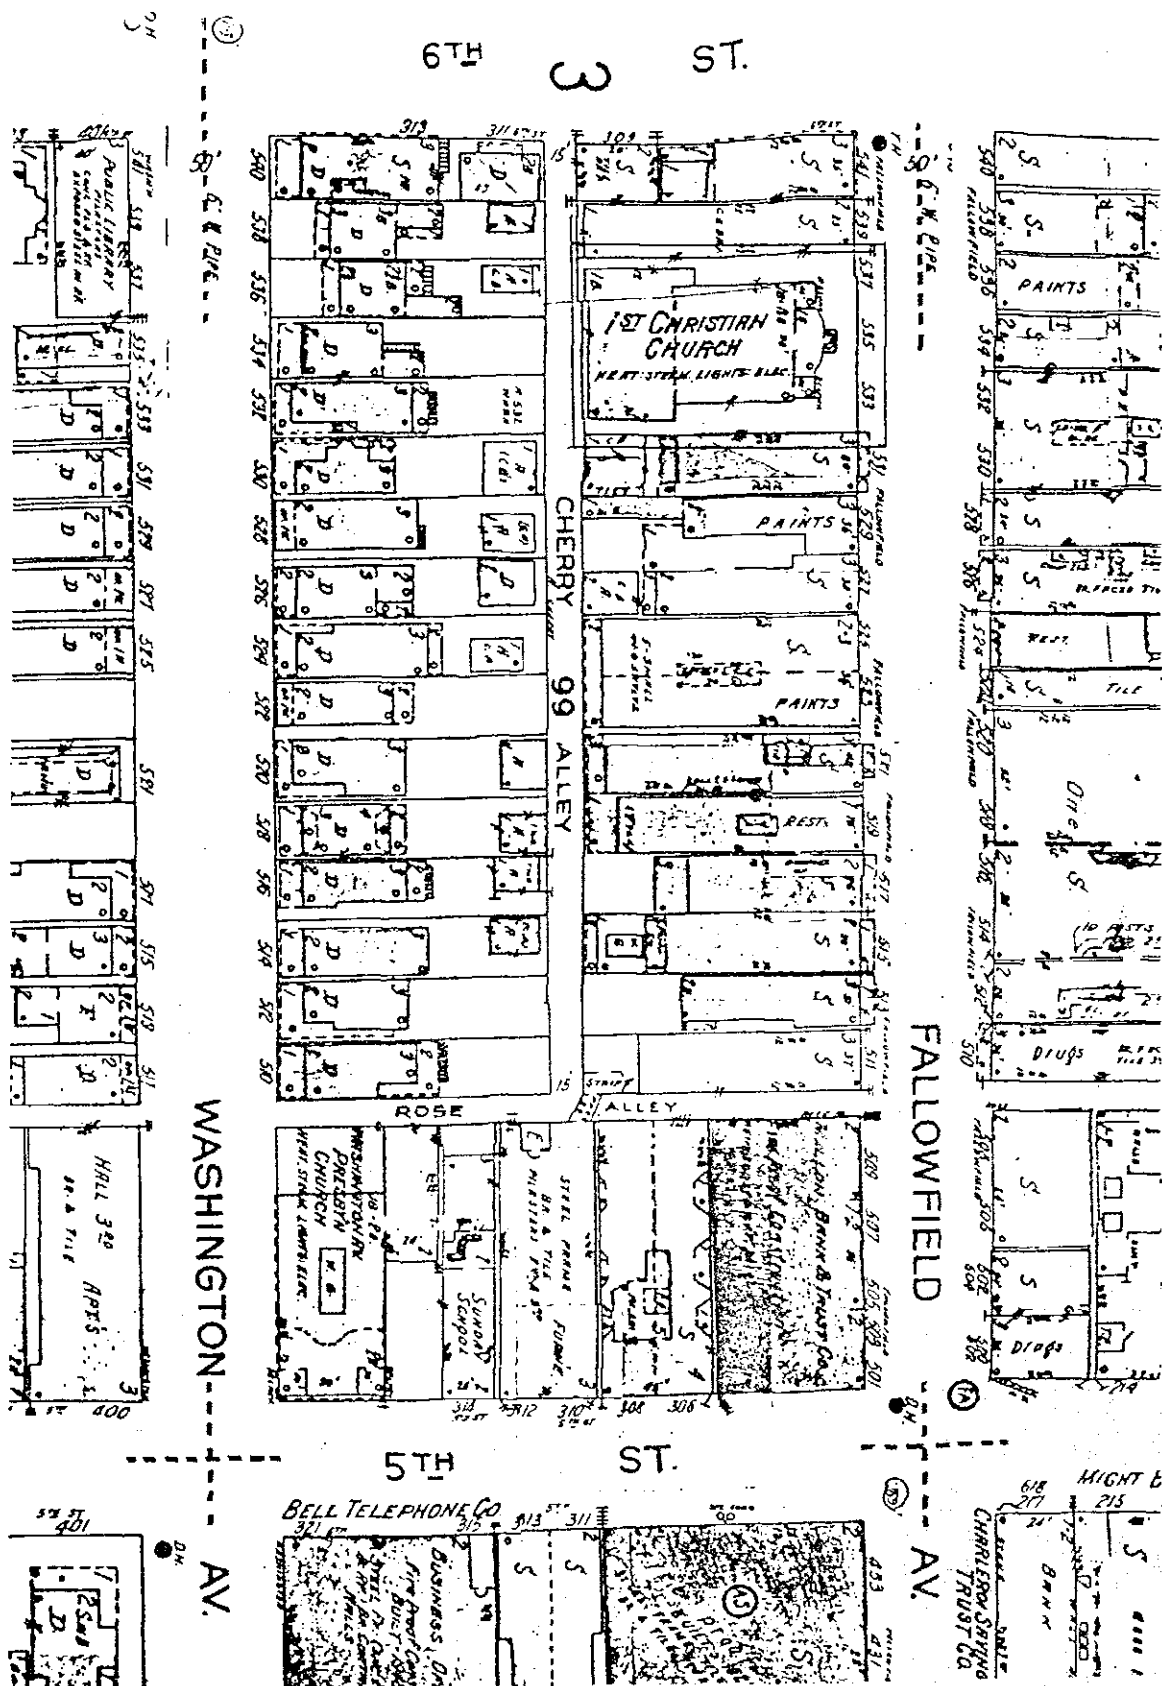
First Floor Above Grade

1. Overall dimensions: Lot - 66' x 100'
Building - 58' x 94' (see sketch)
2. Foundations: Stone
3. Walls: Solid masonry with brick and stone exterior and plaster interior.

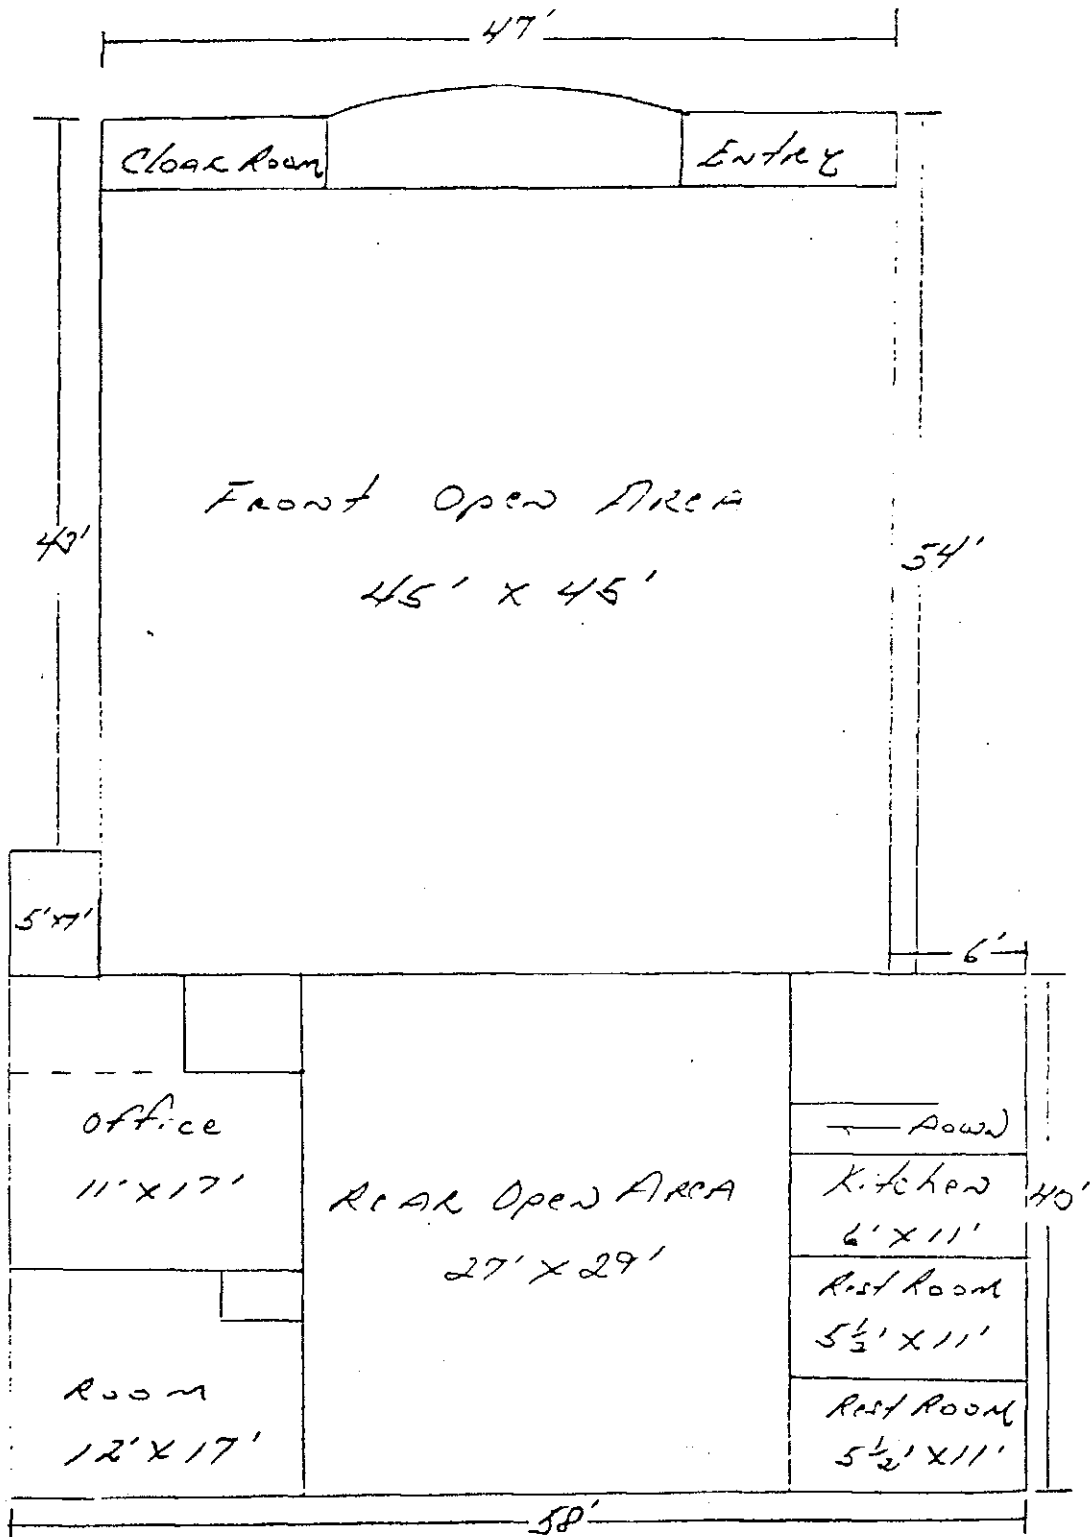
1. Floor Plans: See sketch
2. Stairways: One wood frame type with finish oak railing and balusters. Stair treads have rubber finish.
3. Flooring: Hardwood floors
Basement concrete slab

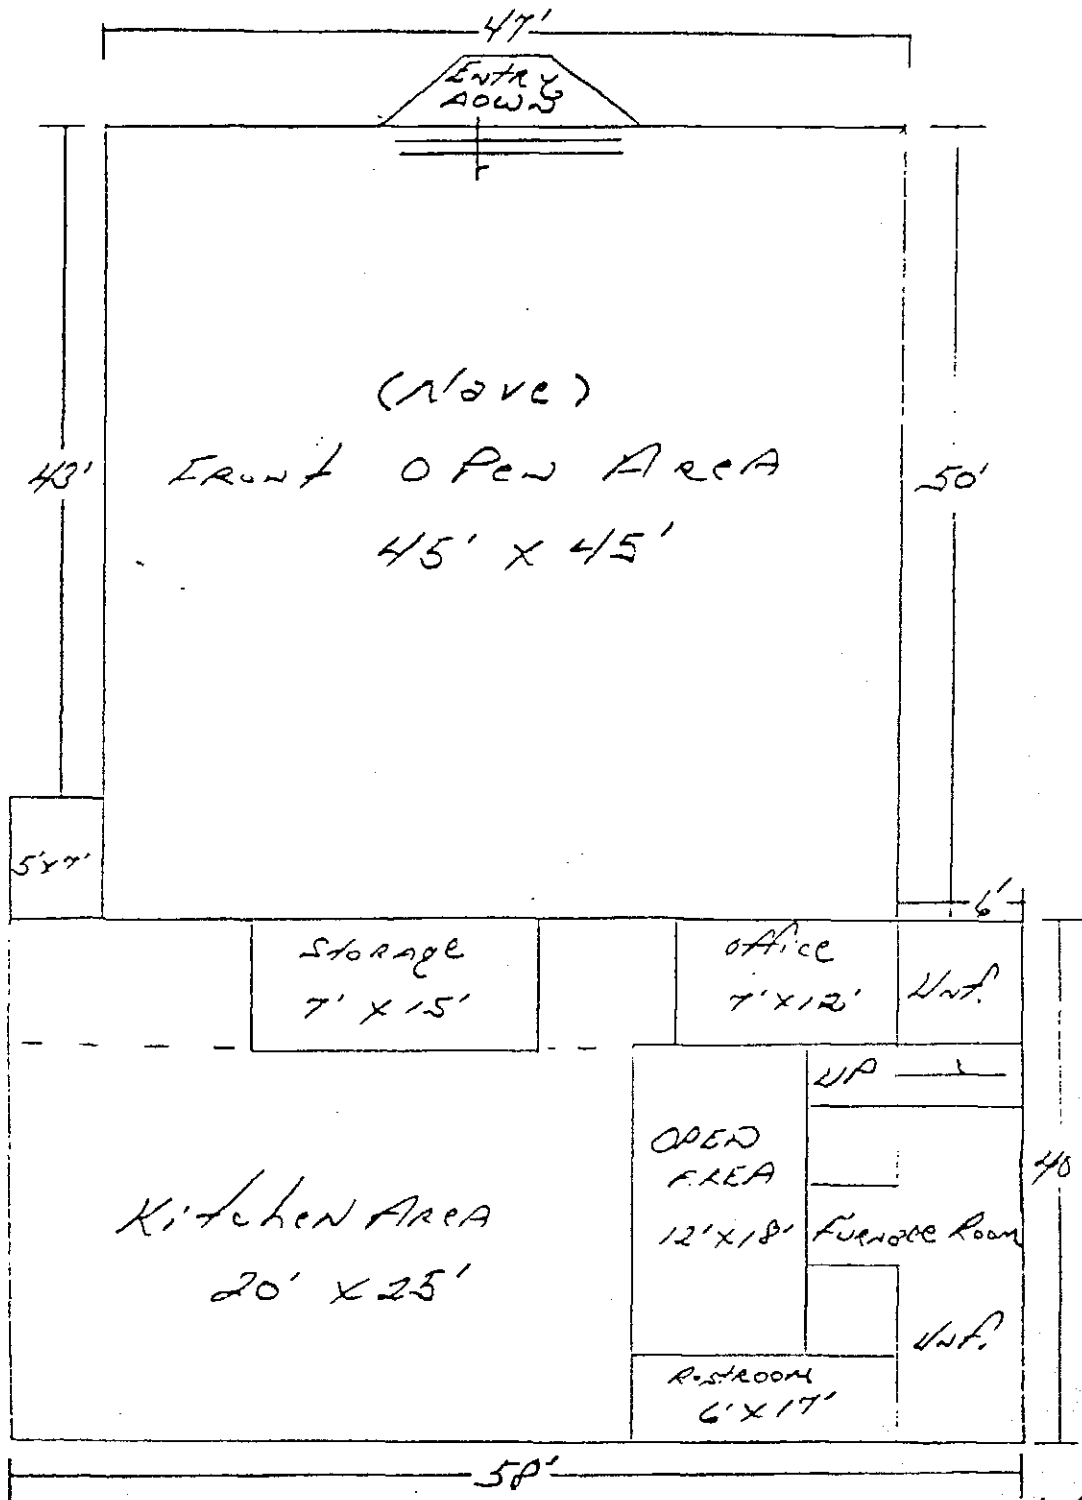
Basement Area

4. Structural Systems, framing: Wood framed floors and roof
Concrete slab basement floors.
5. Porches, stoops, balconies, bulkheads: Two stone & concrete front porches
& stairs with wrought iron railings.
